**Table of Contents for 504 East 8<sup>th</sup> Street Tree Permit**  
**Heritage Tree Variance Package**

**ITEM FOR PLANNING COMMISSION AGENDA**

**ADDRESS**  
**OF PROPERTY:** 504 EAST 8<sup>TH</sup> STREET

**SUBJECT:** 504 East 8<sup>th</sup> Heritage Tree Ordinance Variance

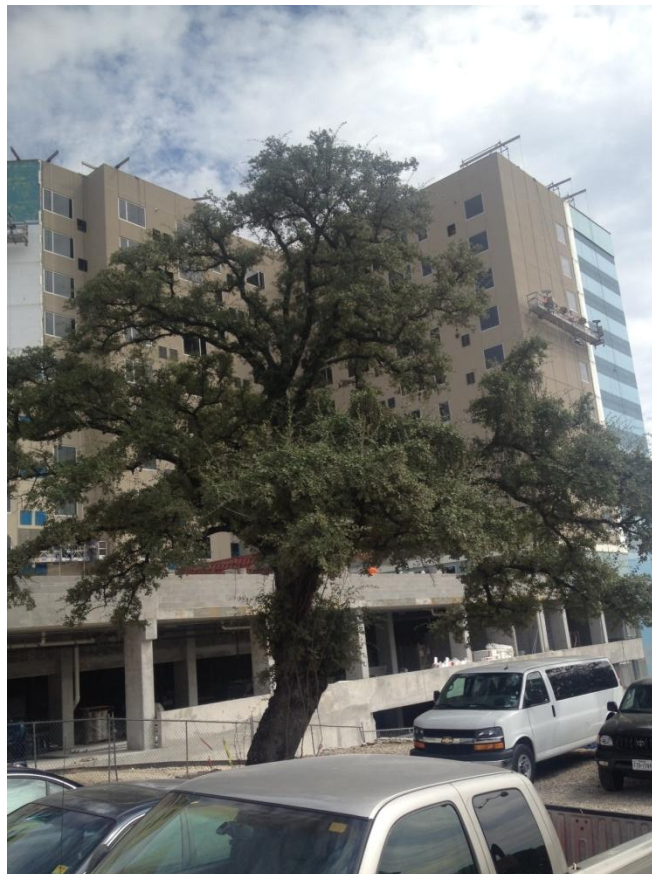
RE: 504 E. 8th st. Austin Tx. 34" Escarpment Live Oak

Following is our health assessment based on the site visit performed on Monday October 5<sup>th</sup> 2015.

**Limits:** Root collar is partly buried. Vines cover section of the stem.

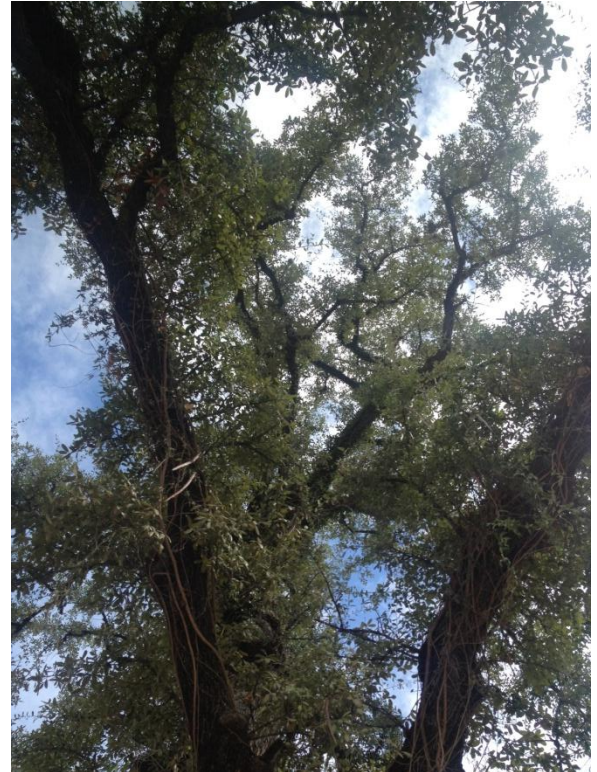
The tree is in good health if the response to stress and vigor of sprouting is the measuring factor. Unsurprisingly, due the reduced pervious cover and the past drought years, it does display a history of past stress but still does not show signs of terminal illness. It does show a pattern of recovery after extreme stress in the form of recent vigorous growth combined with dense sprouting along the branches.

Although the site conditions are less than favorable, we believe this specimen is showing that famous resiliency typical of Central Texas Live Oaks, who are known to be able to retrench when in periods of high stress and bounce back when conditions are more favorable. This year's spring rain have boosted many older Live oaks like this and spurred them into a recovery pattern. These recovery patterns can only last if no terminal opportunistic illnesses are able to settle or borer insects attack.

If this tree is to be preserved, we recommend a thorough multi-year preservation plan that will account for protection against insect and disease attacks as well as improve the site conditions. Improvements should include increasing pervious cover by removing asphalt trough as much of the CRZ as possible, incorporating organic matter in the top layer, occasional watering to supplement natural rainfall, and protecting the surface with a layer of mulch, ideally leafy mulch. The root flare should be restored as much as practical and protected by a tree well if the grade change warrants it. Additionally, a yearly fertilizer application can accelerate the recovery and will then need to be gradually phased out.
